Re: January 2018 Monthly Progress Report  
Administrative Settlement Agreement and Order on Consent for Removal Action  
USEPA Region 10 Docket No. CERCLA 10-2009-0255  
Gasco Sediments Site within the Portland Harbor Superfund Site

Attachment A Monthly Visual Monitoring Report for Pilot Cap Vicinity

# Visual Observations Log Form

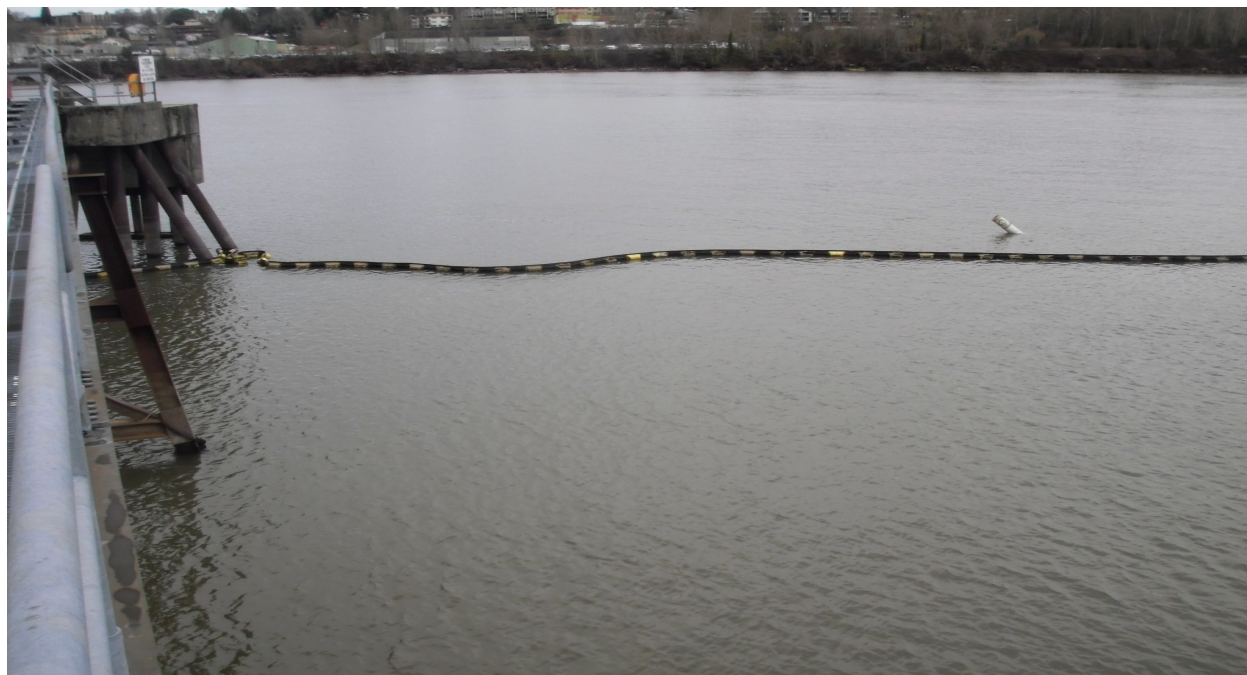
**Photo 1**

During the observation, the FAMM containment boom was placed across the cap area from the ship dock to the upriver dolphin. One of two buoys that identify the cap area to mariners is missing, leaving only one in place as installed. The positions of the FAMM oil boom and warning buoy are shown in Photo 1.

**FAMM Oil Boom Placement and Mariner Warning Buoy at Pilot Cap Area (1/25/2018)**

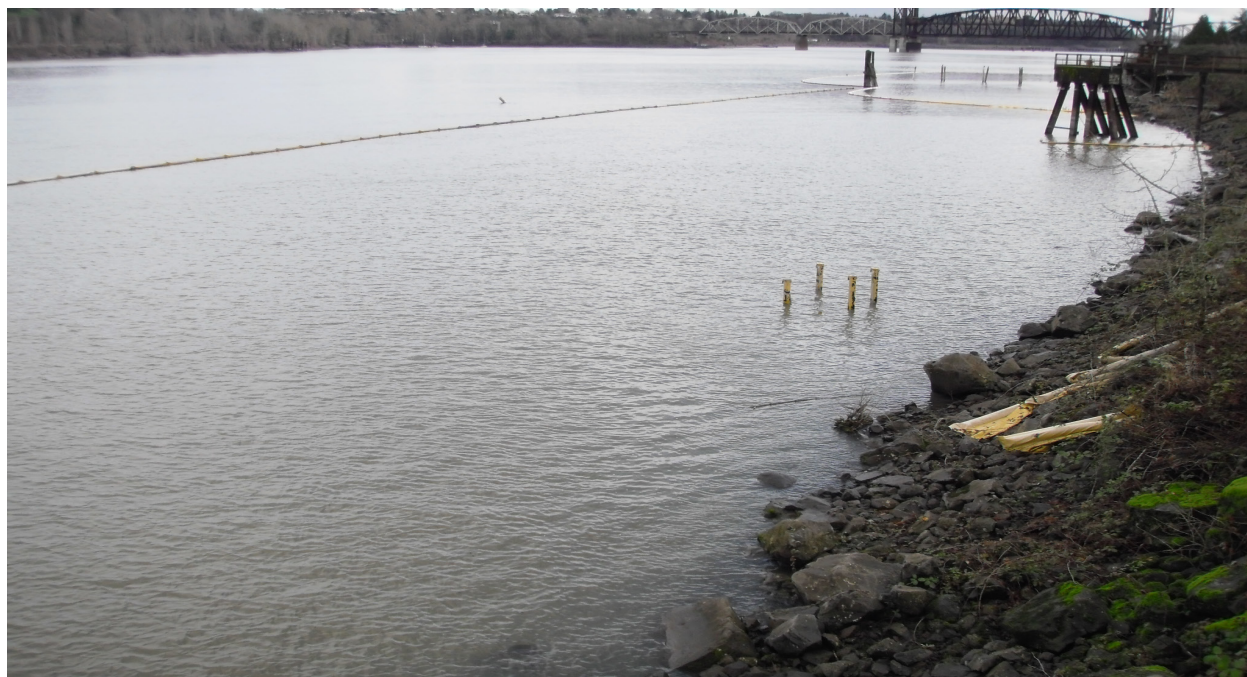
**Photo 2**

The shoreward extent of the cap was not visible due to high river water elevation and the organoclay mat material shoreward of the cap area could not be observed (Photo 2).

**River Level Currently Above the Extent of Sediment Cap (1/25/2018)**

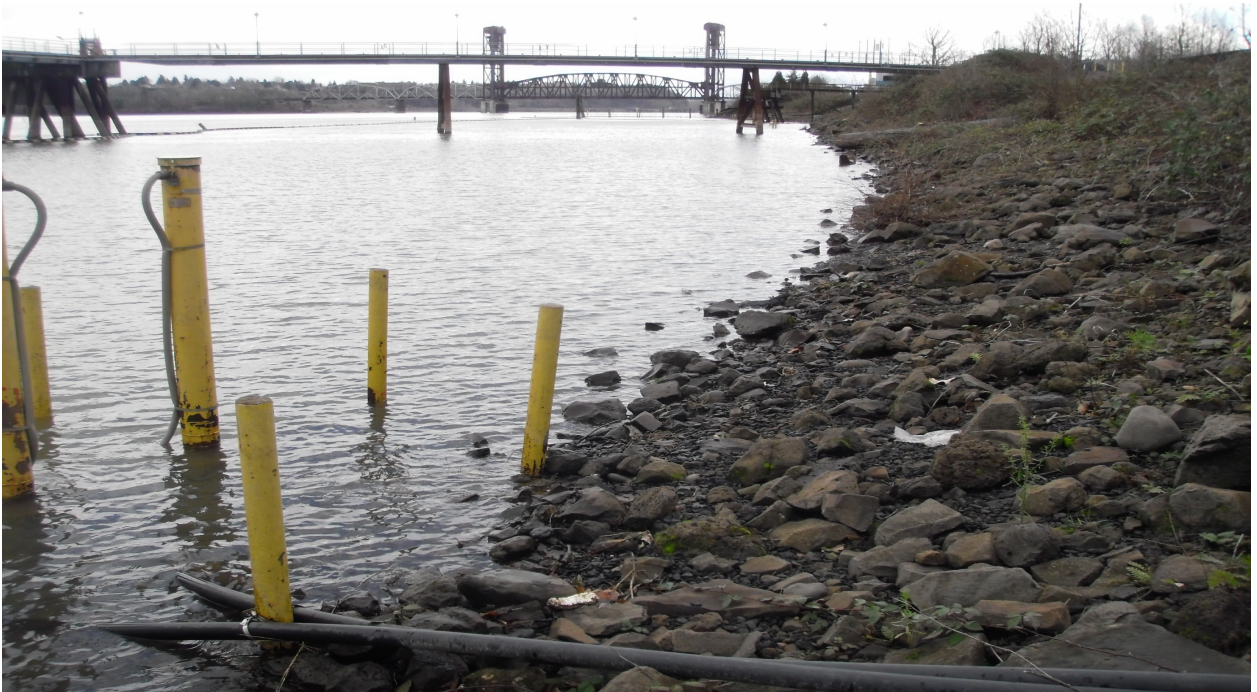
No sheen is evident in or around the cap area. Photo 3 shows the water surface and shoreline immediately downriver of the sediment cap.

**Photo 3**  
**Conditions Immediately Downriver of Cap Area (1/25/2018)**
